Project: Purley Leisure Centre, Croydon

Asset Register

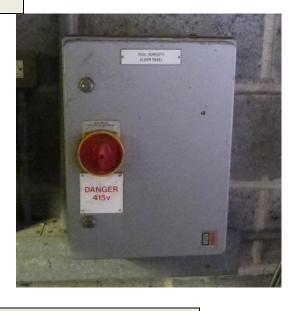
2.M.6

Pool humidity alarm panel

Grade B

Condition of the panel is satisfactory and fair for its age.

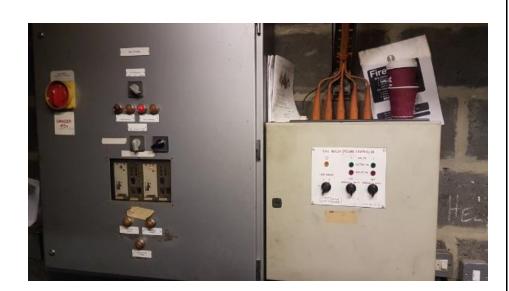
4.M.11

Boiler cycling control panel

Grade C

No change - Whilst boiler and plant are operating we do not deem them to be operating efficiently.

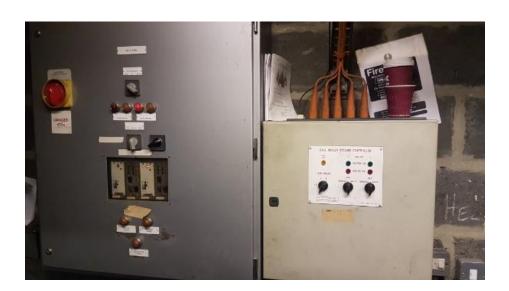
4.M.12

Grade C

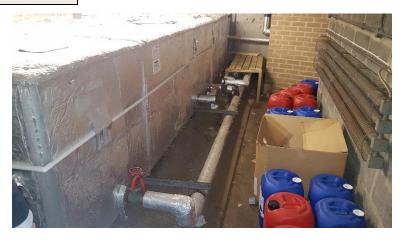
Frost protection heaters

Grade B
